RESERVE FUND STUDY BEECH MOUNTAIN LAKES ASSOCIATION, INC.

BEECH MOUNTAIN LAKES
ASSOCIATION, INC.
1 BURKE DRIVE
DRUMS, PA 18222

YINGST ENGINEERS & ASSOCIATES, INC.
PROJECT No. 15-0061

December 7, 2015

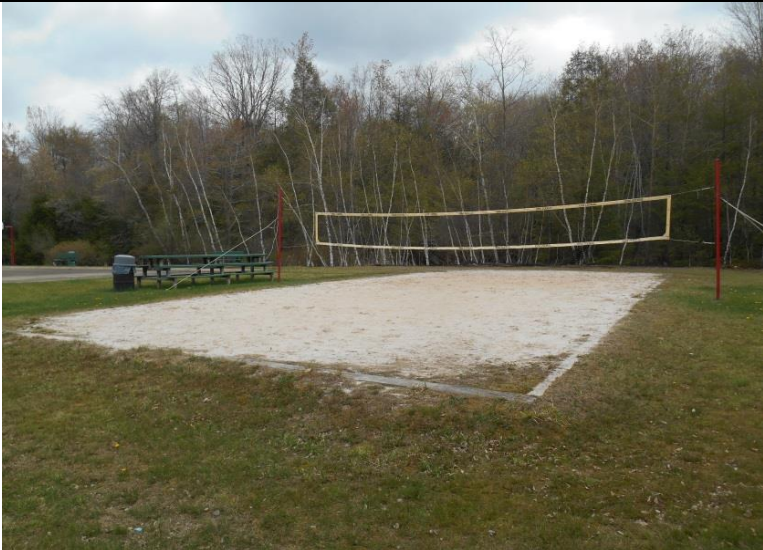
<i>View of community volleyball court.</i>
2

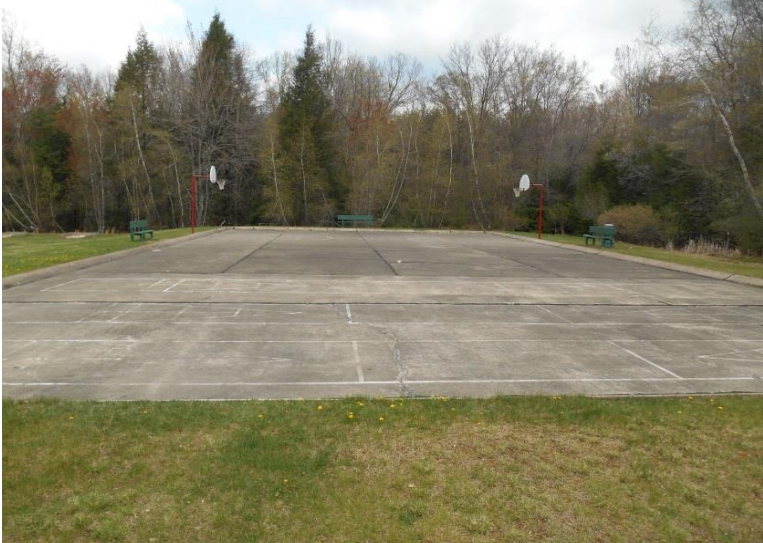
<i>View of community basketball court.</i>
3

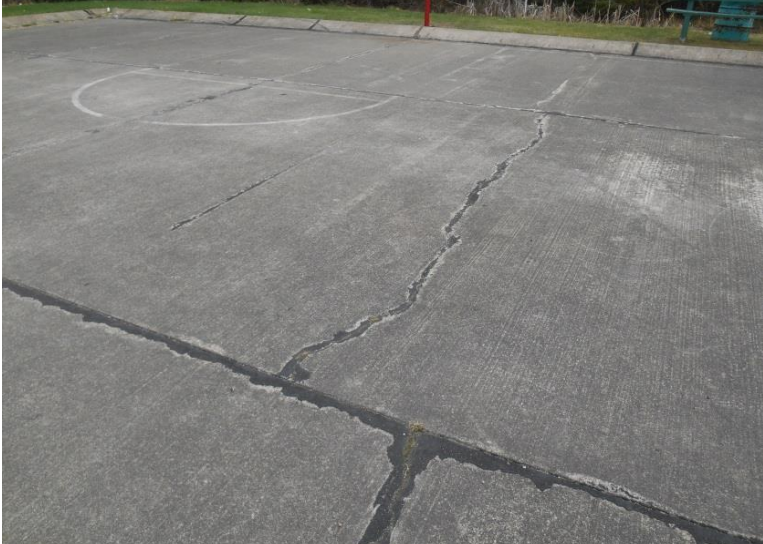
<i>Typical view of cracking and general deterioration of basketball court surface.</i>

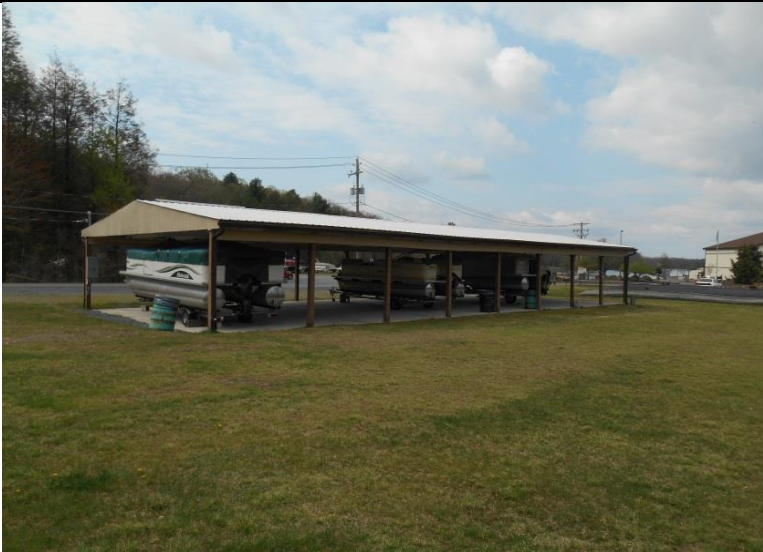
<i>View of open-frame pavilion structure.</i>
5

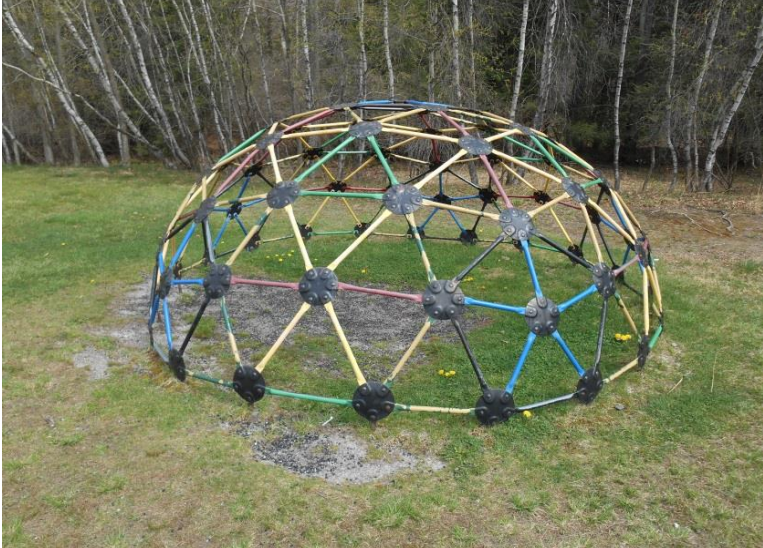
<i>View of aging steel dome climbing apparatus.</i>
6

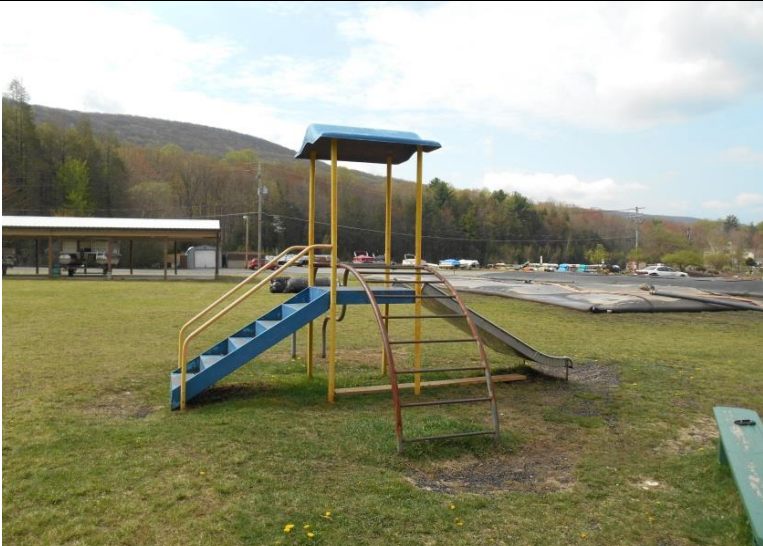
<i>View of metal slide with climbing bars.</i>

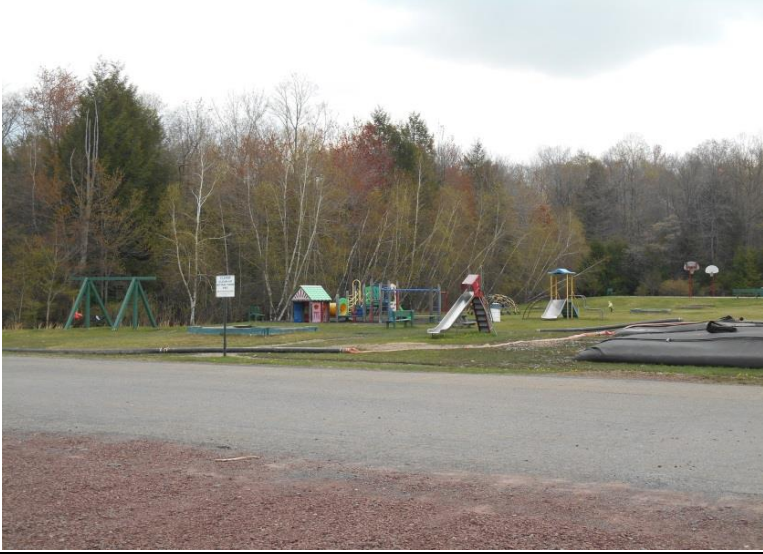
A wide-angle photograph of a playground area. In the foreground is a large, flat, light-colored gravel or sand area. In the middle ground, there is a colorful playground structure with slides and climbing equipment. The background consists of a dense line of trees with some autumn-colored foliage under a cloudy sky.	<p><i>Overall view of playground apparatus near clubhouse building.</i></p>
11

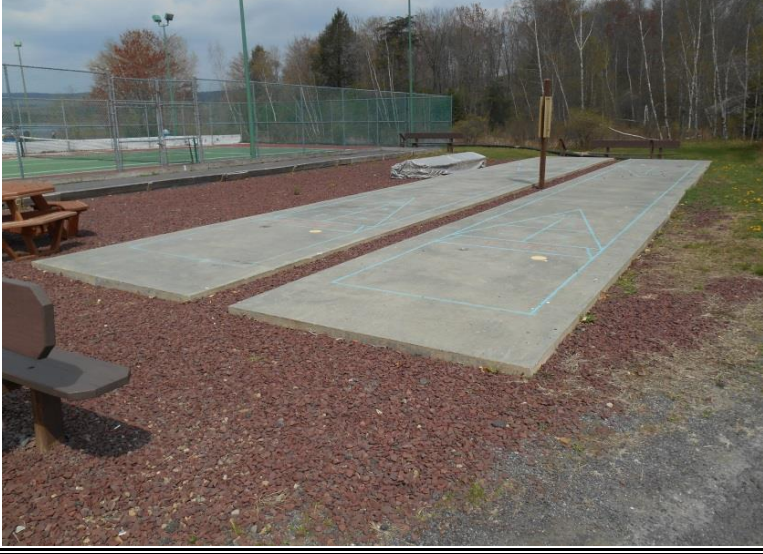
A photograph showing two long, rectangular concrete shuffleboard pads. The pads are set on a bed of reddish-brown mulch. Blue lines are painted on the concrete to indicate the playing area. In the background, there is a green chain-link fence and some trees.	<p><i>Typical view of two concrete shuffleboard pads.</i></p>
12

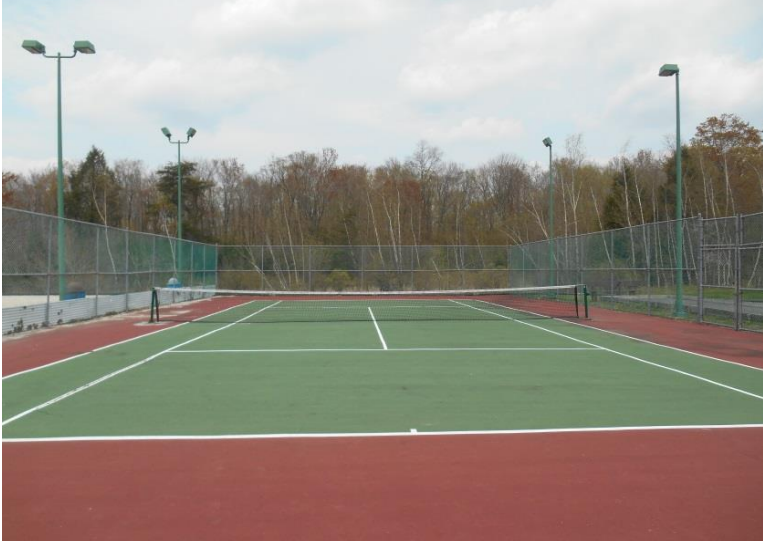
A photograph of a tennis court. The court has a green playing surface with white lines and a red outer boundary. Several tall, green light poles are positioned around the court. The court is enclosed by a chain-link fence, and trees are visible in the background under a cloudy sky.	<p><i>View of tennis court and associated light poles.</i></p>

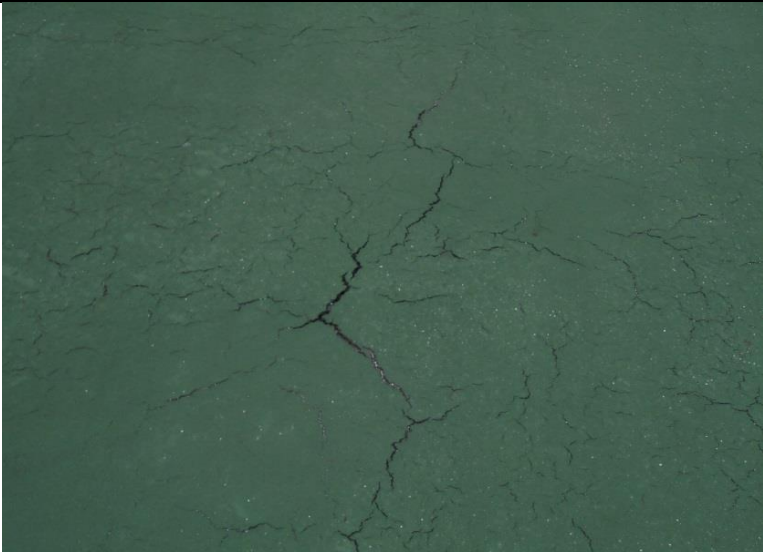
<i>View of aging and cracking tennis court surface (typical view).</i>
14

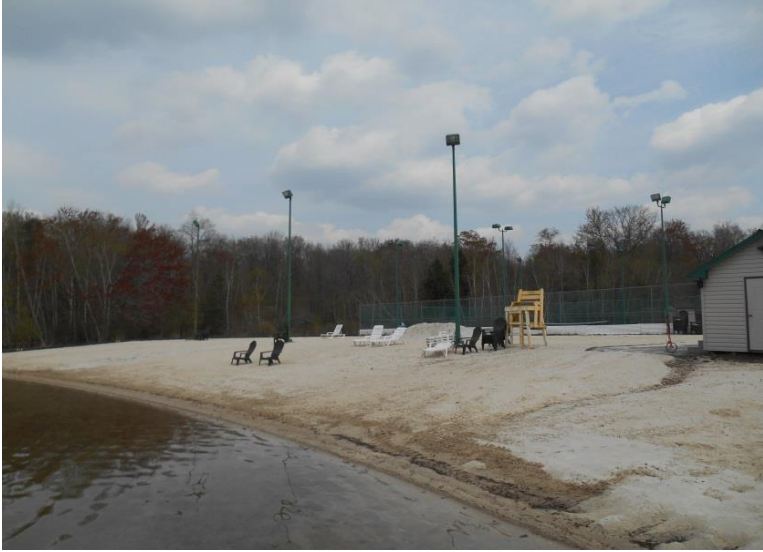
<i>General view of clubhouse beach area.</i>
15

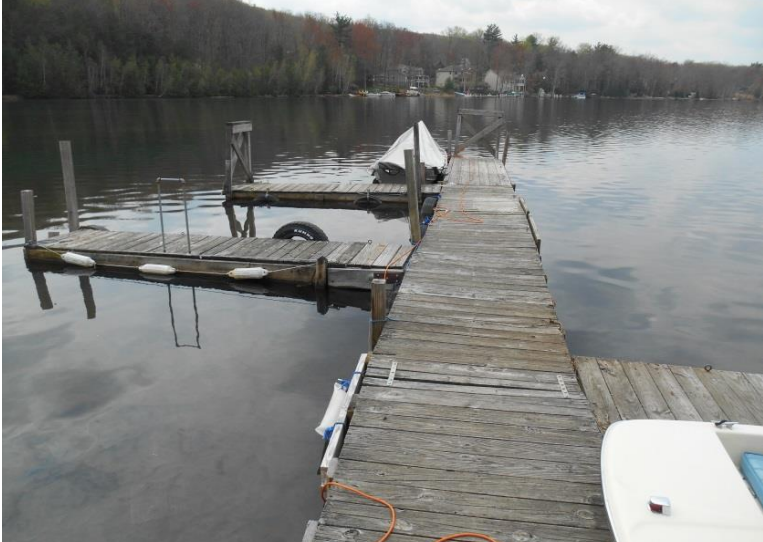
<i>View of aging wood dock assembly (Finger D).</i>

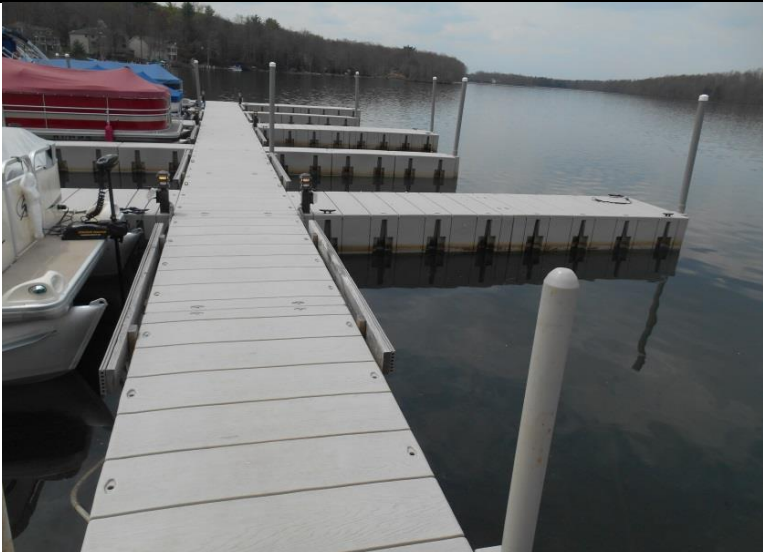
<i>Typical view of one of the newer low-maintenance (vinyl) dock assemblies.</i>
17

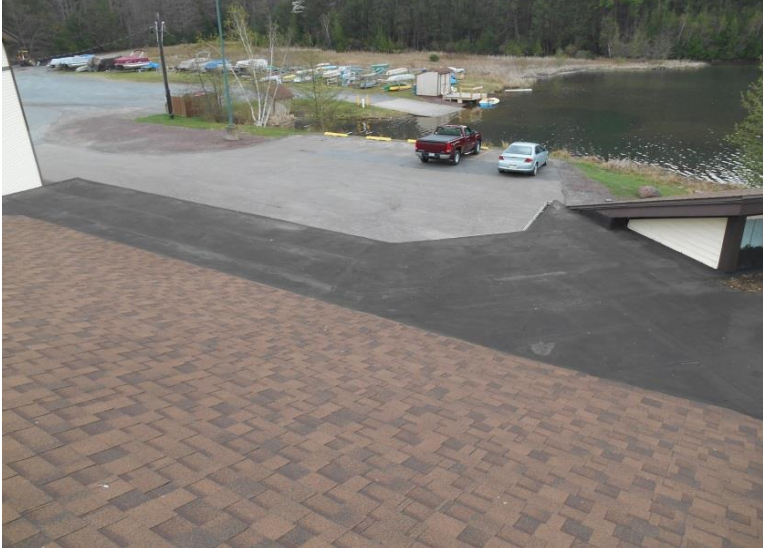
<i>View of parking area and boat launch adjacent to clubhouse building.</i>
18

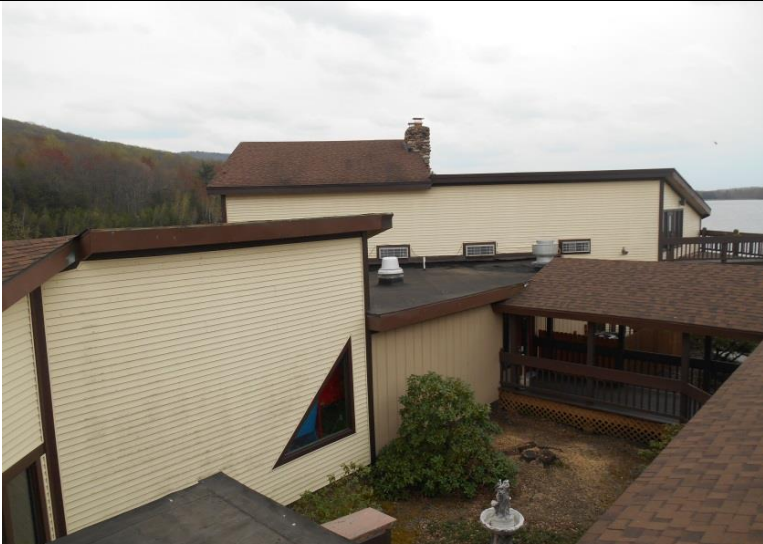
<i>Limited view of clubhouse building roof areas.</i>

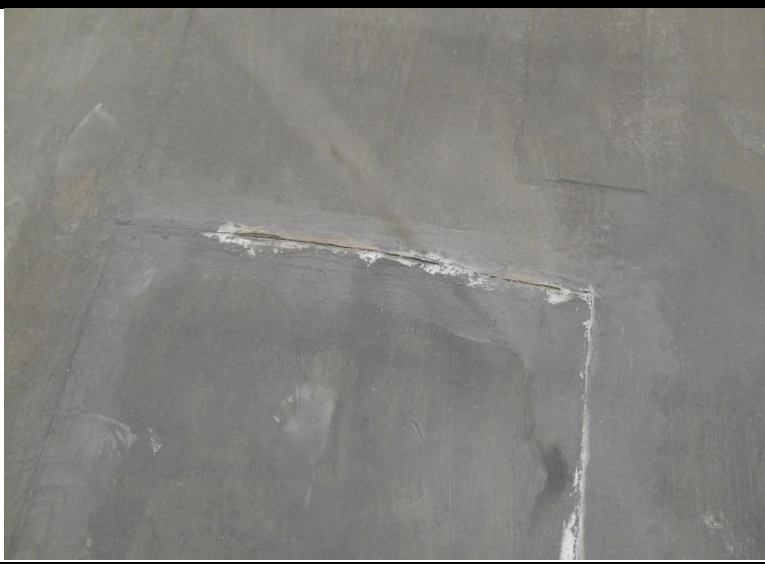
<i>Typical view of cracked and deteriorated roof seam at one of the clubhouse building roof areas.</i>
20

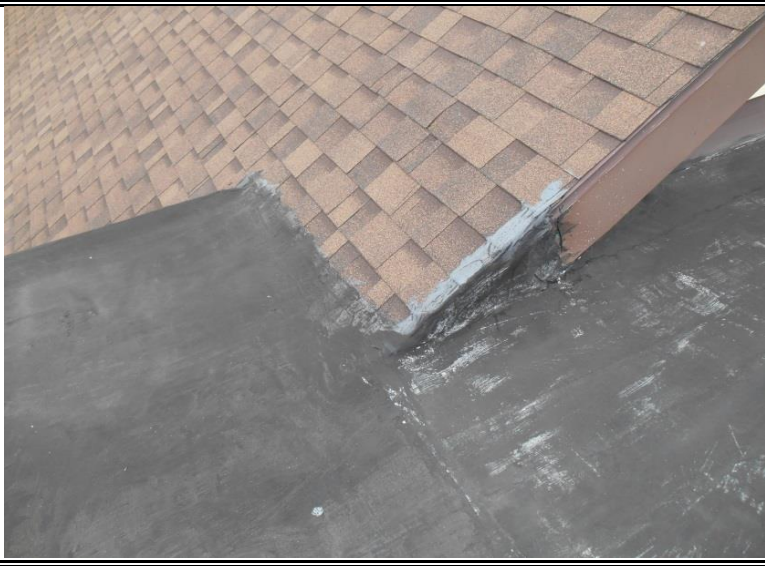
<i>Typical view of poor flashing at flat built-up roof to sloped asphalt fiberglass shingle roof interface.</i>
21

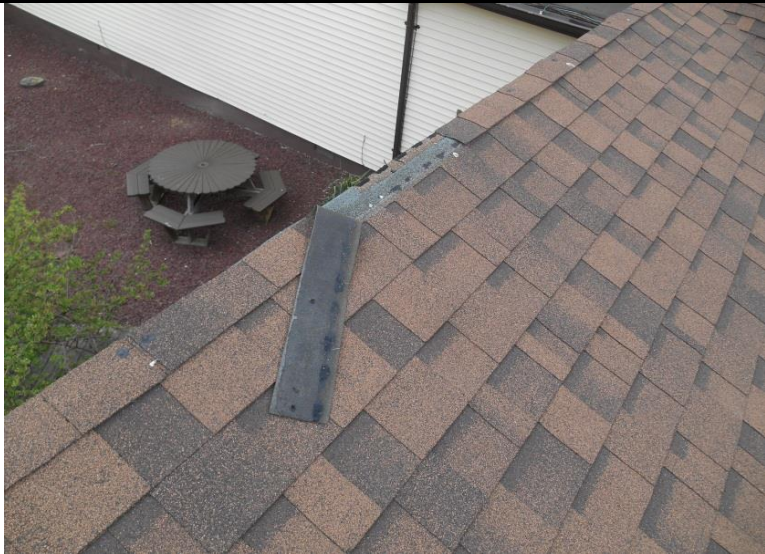
<i>View of loose and torn shingle at one of the lower, rear, secondary clubhouse roof areas.</i>

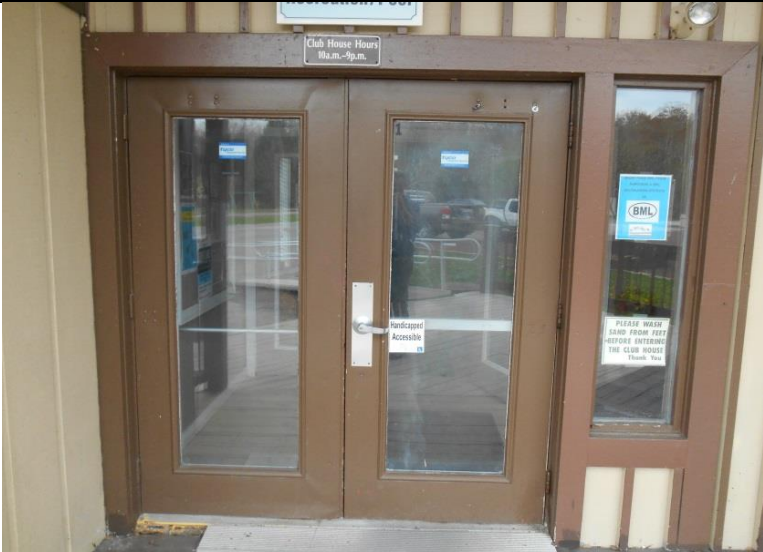
A photograph of a double glass door entrance to a clubhouse. The doors are framed in a dark brown wood-grain material. Above the doors is a small sign that reads "Club House Hours 10a.m.-9p.m.". To the right of the doors is a vertical glass panel with a blue sign that says "BML" and a white sign that says "PLEASE WASH HANDS FROM EXTERIOR BEFORE ENTERING THE CLUB HOUSE Thank You". A "Handicapped Accessible" sign is on the door handle.	<i>View of aging main entrance door assembly at clubhouse.</i>
23

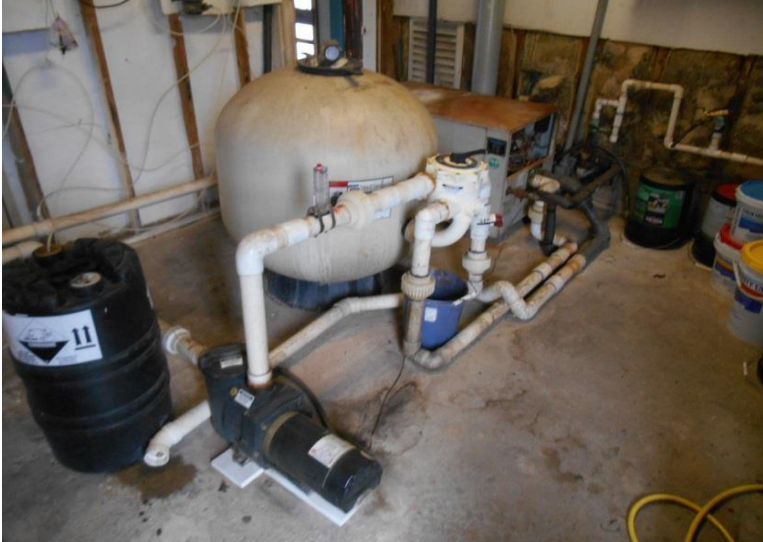
A photograph of the pool mechanical room. It features a large, tan-colored cylindrical sand filter tank in the center. To the left is a black motor unit. Various white PVC pipes connect the equipment. In the foreground, there is a black barrel with the number "11" on it. The room has a concrete floor and some clutter in the background.	<i>View of pool mechanical equipment.</i>

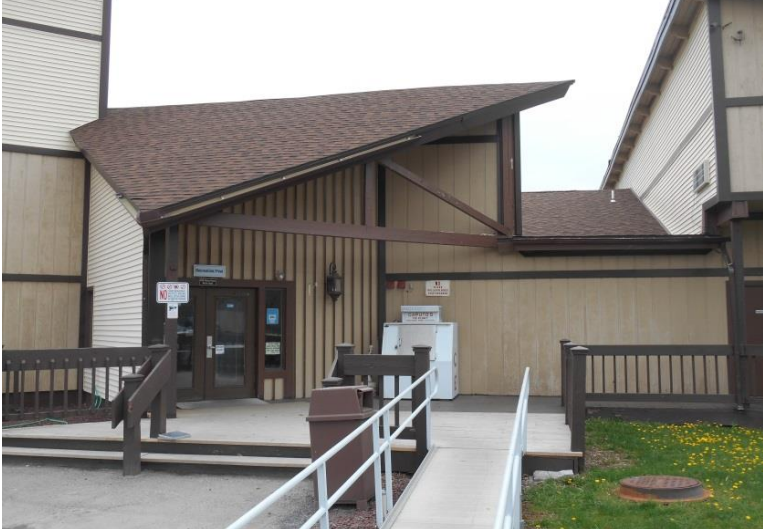
A photograph of the exterior of the clubhouse. It shows a covered entrance area with a dark brown roof. A concrete ramp with white handrails leads up to the entrance. The building has light-colored horizontal siding and dark brown trim. There are some plants and a manhole cover in the foreground.	<i>View of main Clubhouse entrance along front side of building.</i>

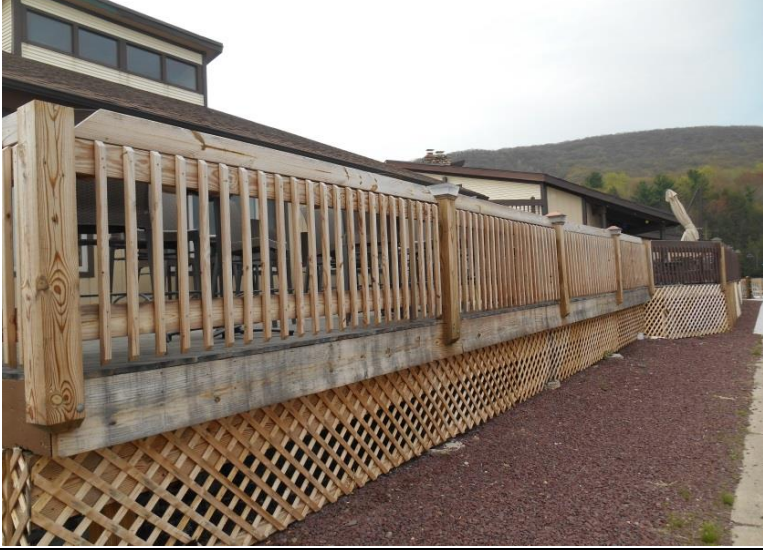
These deck structures vary in age and condition. Further, it was reported that the community room deck was installed in 2012 and approximately 50% of the deck boards at the restaurant deck were replaced. We also identified areas of new deck boards at the front entrance deck/landing.

<p><i>Partial view of rear side of building and large deck structure.</i></p>
27

Based on site measurements, the community maintains approximately 6,590 square feet of deck at the above noted clubhouse areas. Recognizing the Association's historical approach to deck upgrades, we have included an allowance for regular deck upgrades (i.e., decking and guardrails) over the study period.

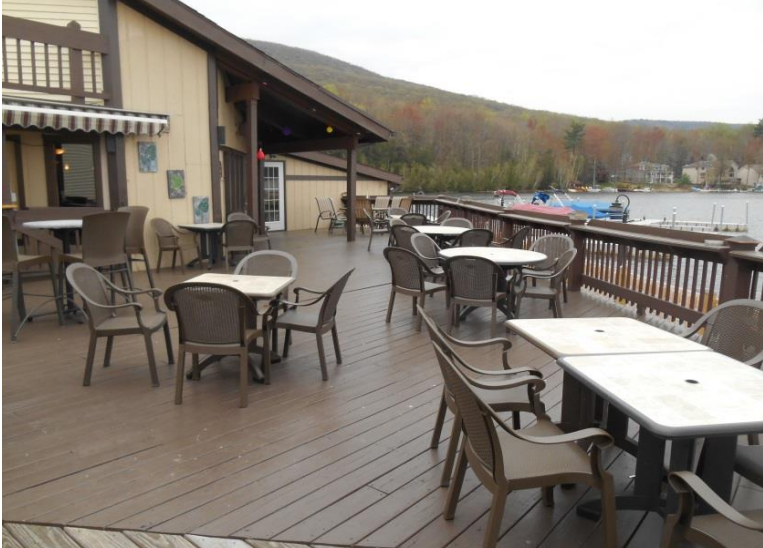
<i>Partial view of large deck structure along rear side of building.</i>
29

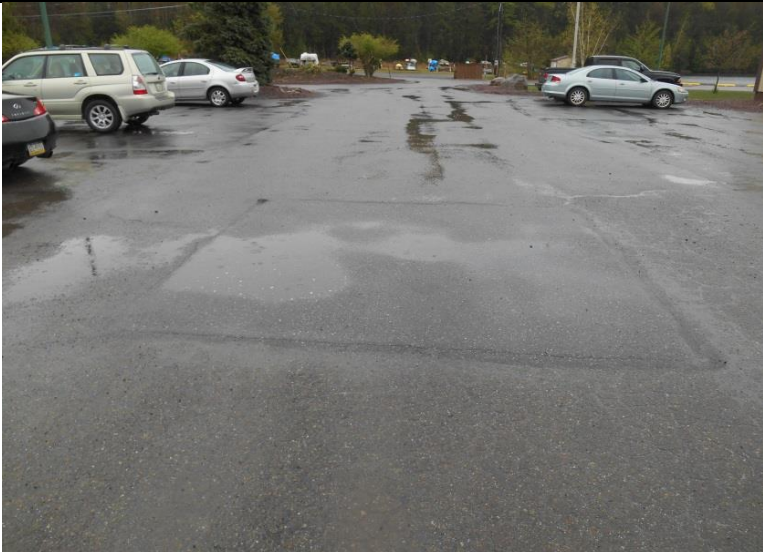
The paving at the clubhouse has exceeded its typical useful life and is in fair to poor condition. For the purposes of this study, we have assumed resurfacing in Year 1.

<p><i>General view of Clubhouse parking lot. Note surface depressions and ponding water.</i></p>
44

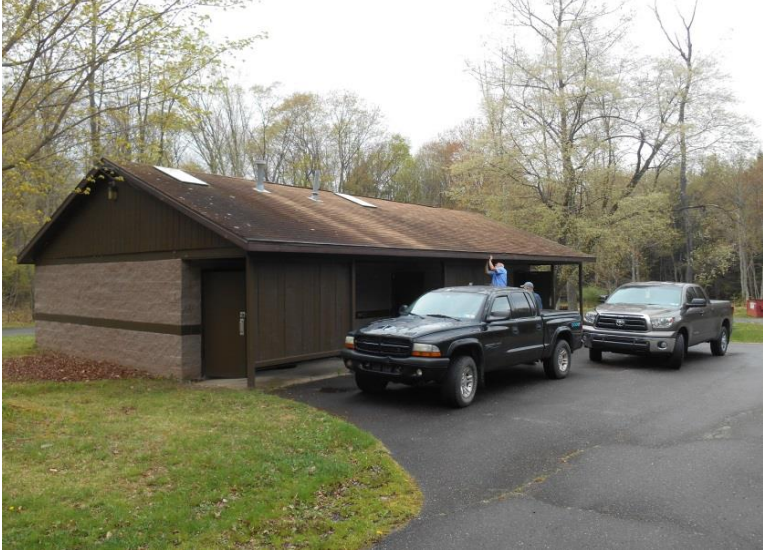
We have assumed replacement of approximately 210 square feet of cracked and offset sidewalk along the front side of the bathhouse building in Year 1. In its current condition, this sidewalk represents a potential tripping (and liability) hazard.

<i>View along front side of bath house at community campground.</i>
54

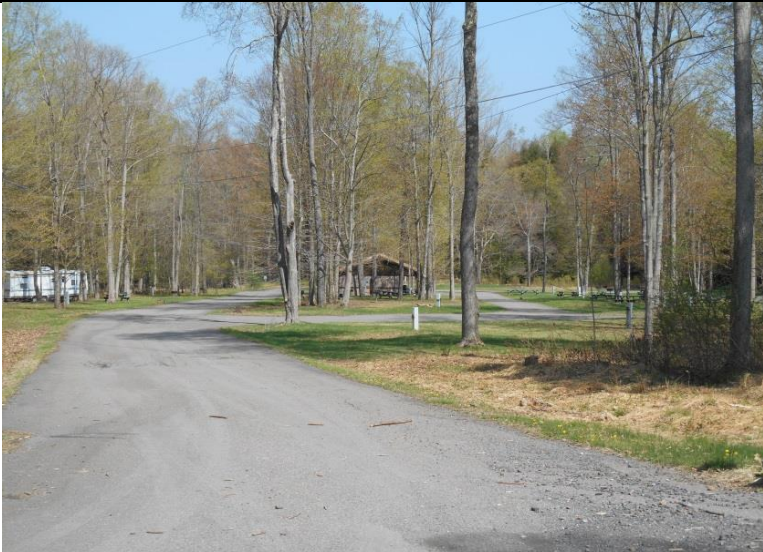
While aging, the paving at the campground remains in fair to good condition. Due to limited usage, we assumed another 5 to 10 years of remaining useful life and resurfacing in Year 7 of the study period. This assumes regular maintenance and repairs.

<i>General view of campground and associated paving.</i>
59

We recommend, however, that the paving at the site be kept under close observation and the replacement schedules adjusted if accelerated deterioration occurs. This should be evaluated coincident to future reserve study updates, which are generally recommended every three to five years.

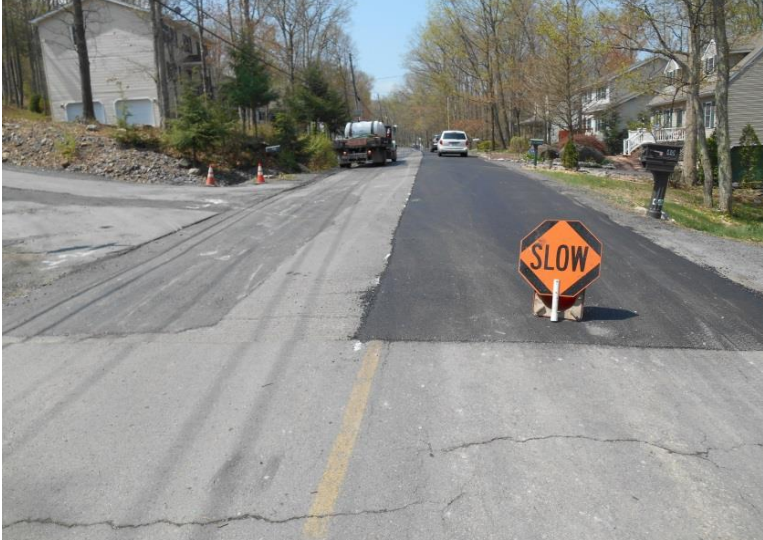
The Beech Mountain Lakes Association owns and maintains approximately 13-1/2 linear miles of asphaltic roadway. Based on information provided by management, approximately 2-1/2 miles of community roads were recently repaved. The remaining roads are reportedly scheduled to be resurfaced over the next five years and in conjunction with a community water line replacement project.

<i>View of newer paved road within community (construction activities ongoing during site investigation).</i>

We recommend that community road surfaces be further evaluated coincident to future Reserve Study updates and the replacement schedules modified as required.

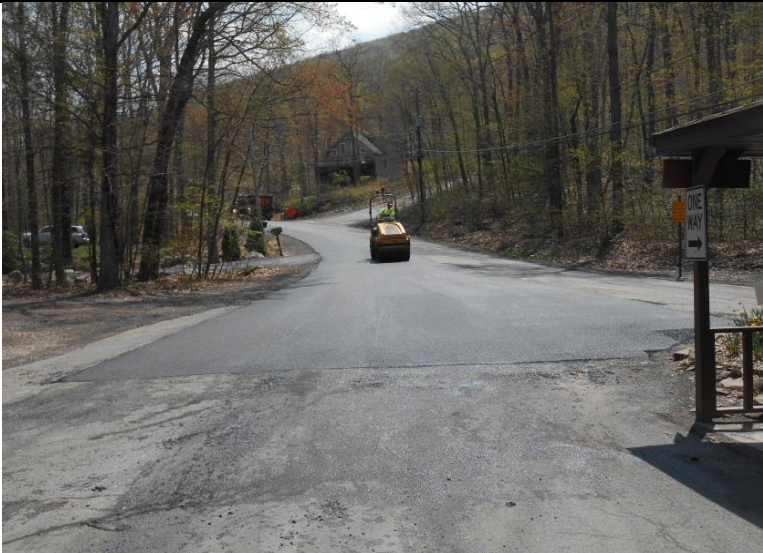
<i>View of paving project near community entrance and guard shack.</i>
